LITTLE RIVER UPPER DAM  
ME 00289

**PHASE I INSPECTION REPORT  
NATIONAL DAM INSPECTION PROGRAM**

**NOVEMBER 1979**

Identification No.: ME00289  
Name of Dam: Little River Upper Dam,  
Town: Belfast  
County and State: Waldo, Maine  
Stream: Little River  
Date of Inspection: September 17, 1979

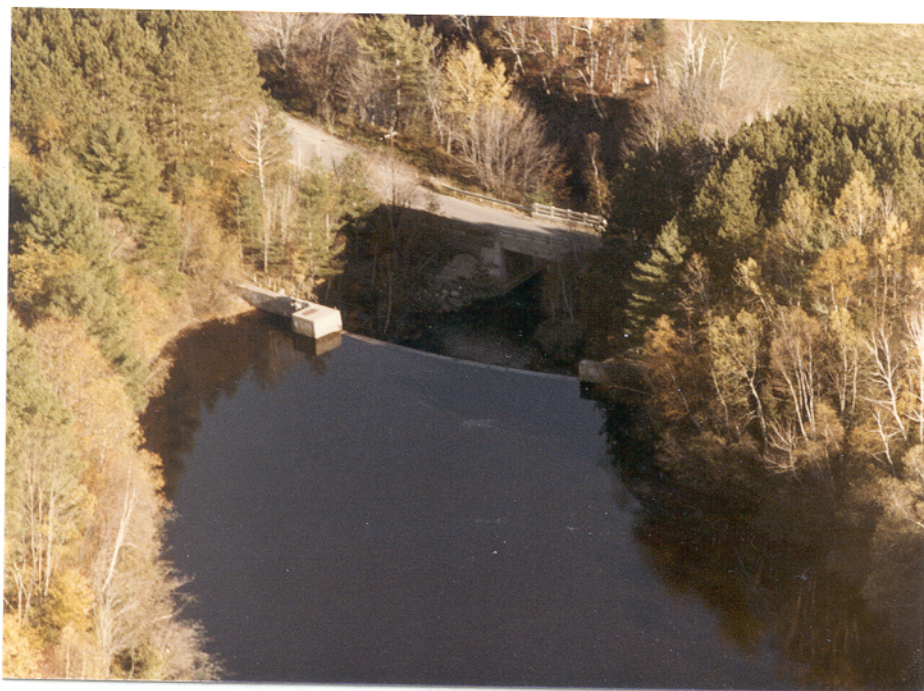
Figure 1 - Overview of Little River Upper Dam.

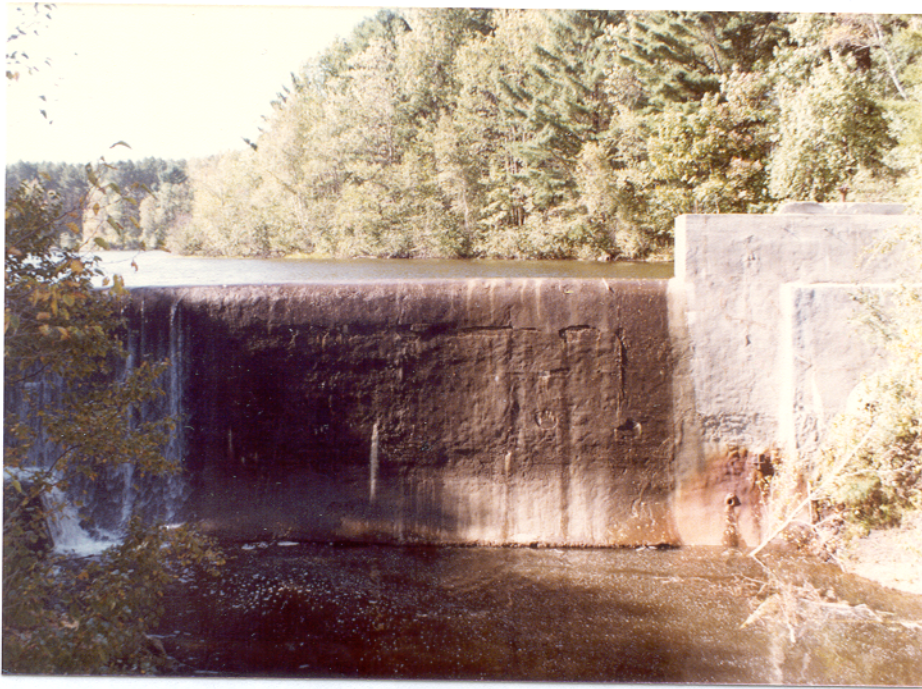
September 17, 1979  
 Figure 2 - Looking at downstream face of Little  
 River Upper Dam.

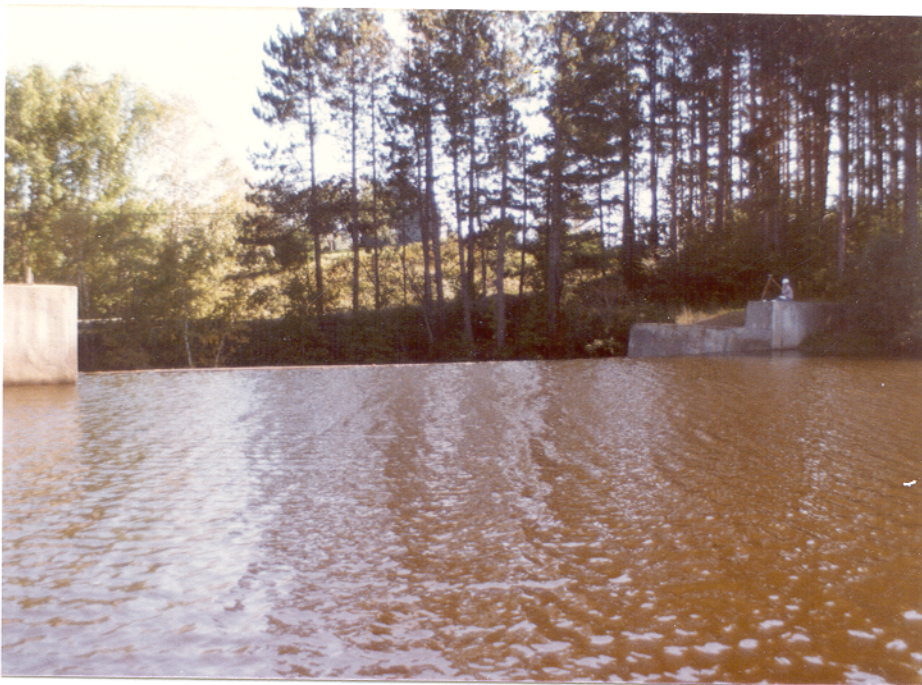
September 17, 1979  
 Figure 3 - View of upstream face of Little River  
 Upper Dam.

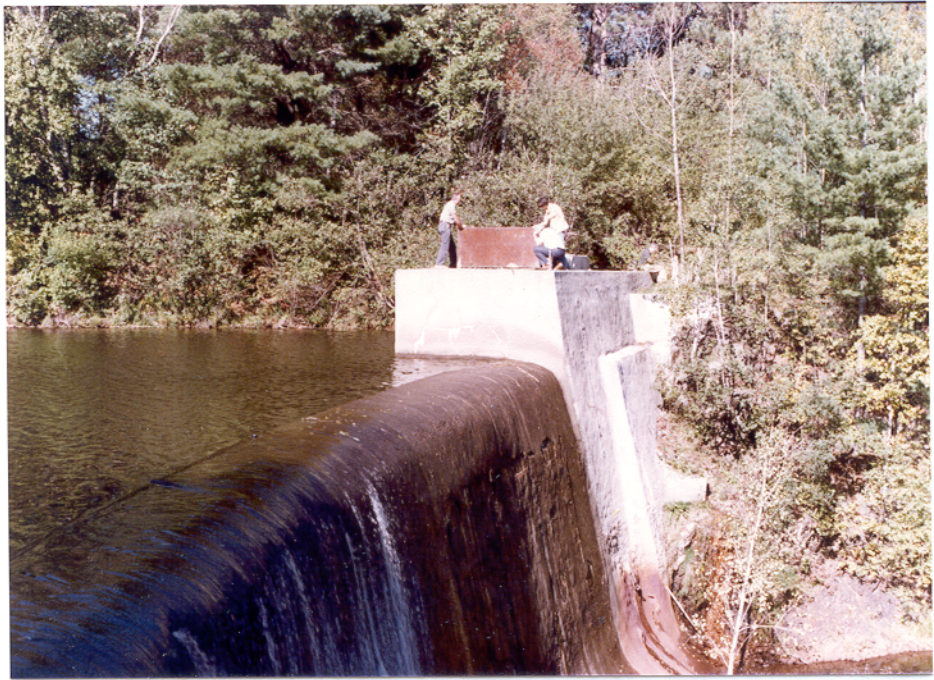
September 17, 1979  
Figure 4 - Looking at north abutment of dam.

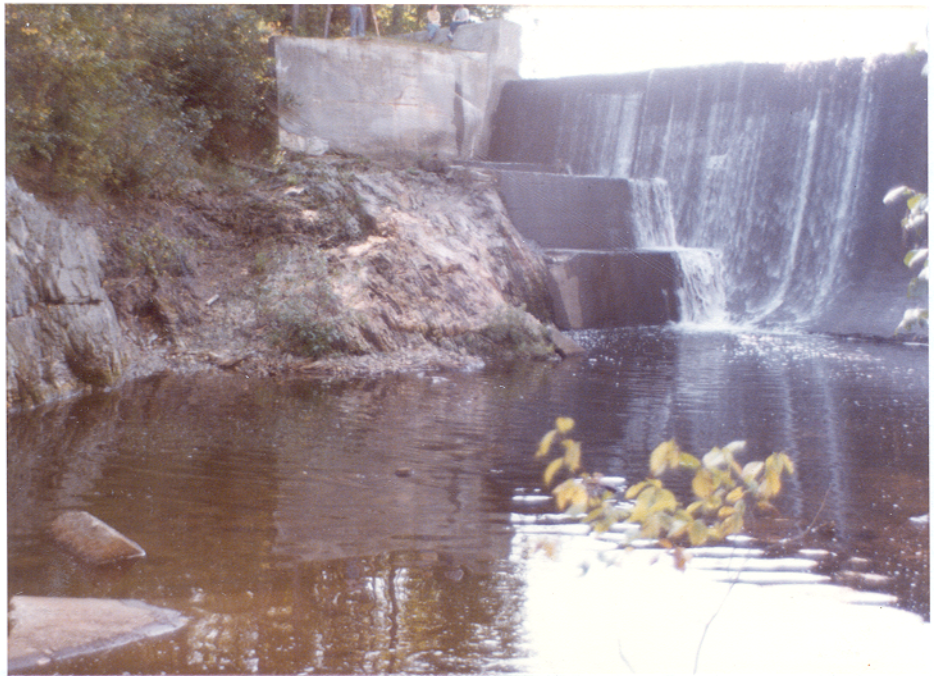
September 17, 1979  
Figure 5 - Downstream face of south abutment.

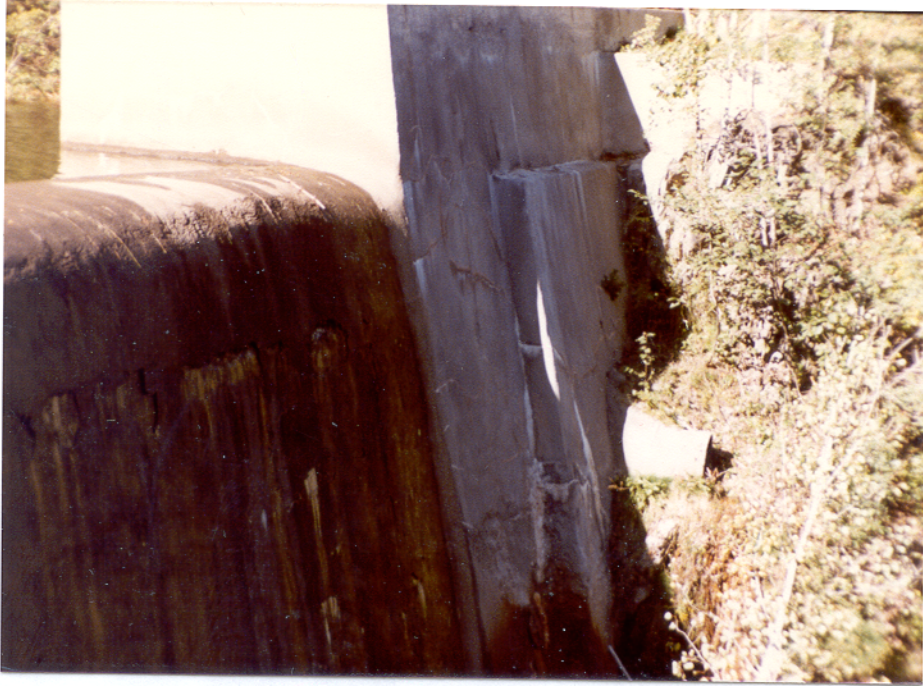
September 17, 1979  
 Figure 6 - Looking at 18-inch outlet pipe at  
 north abutment of the dam.

- (3) Design repairs for the erosion that has occurred on the embankment sections of the dam.
- (4) Design repairs to the cracked and spalled areas of the concrete surfaces.
- (5) Repair or replace plywood cover to the control tower.
- (6) Repair or replace 18" clay tile pipe.

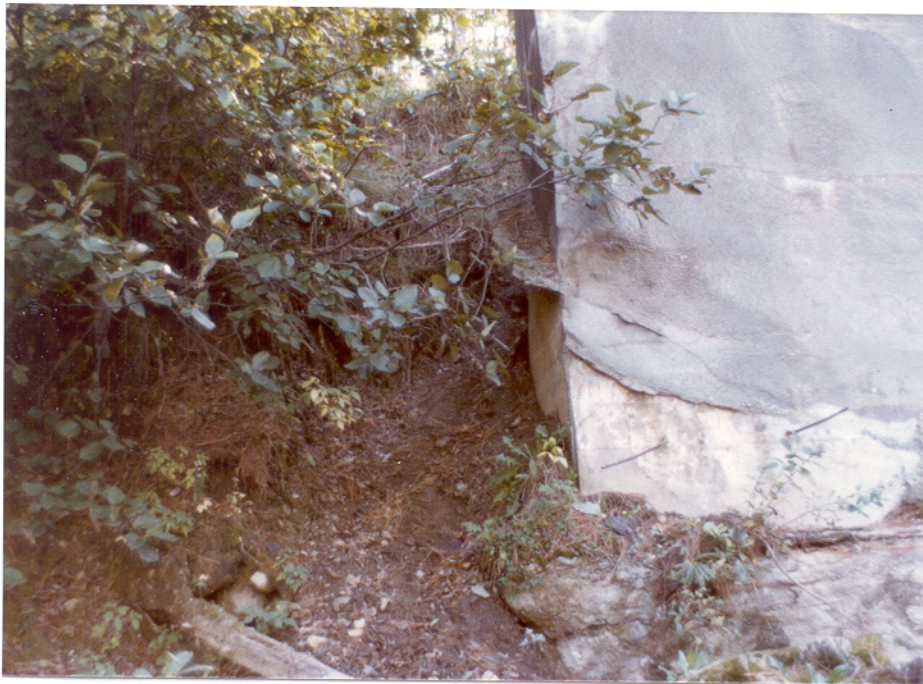
Trespassing on the embankment sections at the south and north abutments has caused major erosion on the abutment side of the downstream training wall at the south end of the overflow section of the dam and loss of vegetation elsewhere. Continued trespassing and erosion may endanger the embankment sections and the training wall. Trees and brush are growing on the embankment sections at the ends of the dam. If a tree blows over and pulls out its roots, or if a tree dies and its roots rot, seepage and erosion problems may result.

Trespassing on the embankment sections at the south and north abutments has caused major erosion on the abutment side of the downstream training wall at the south end of the overflow section of the dam and loss of vegetation elsewhere. Continued trespassing and erosion may endanger the embankment sections and the training walls.

September 17, 1979  
 Figure 7 - View of major erosion on south end of  
 training wall at south abutment.

- (1) Prevent trespassing on the embankment section of the dam.
- (2) Repair or replace plywood cover.
- (3) Clear trees and brush for a distance of 25 feet on either side of the downstream channel between the dam and the highway bridge.
- (4) Visually inspect the dam and appurtenant structures once a month.
- (5) Engage a Registered Professional Engineer to make a comprehensive technical inspection of the dam once every year.
- (6) Establish a surveillance program for use during and immediately after heavy rainfall, and also a downstream warning program to follow in case of emergency conditions.

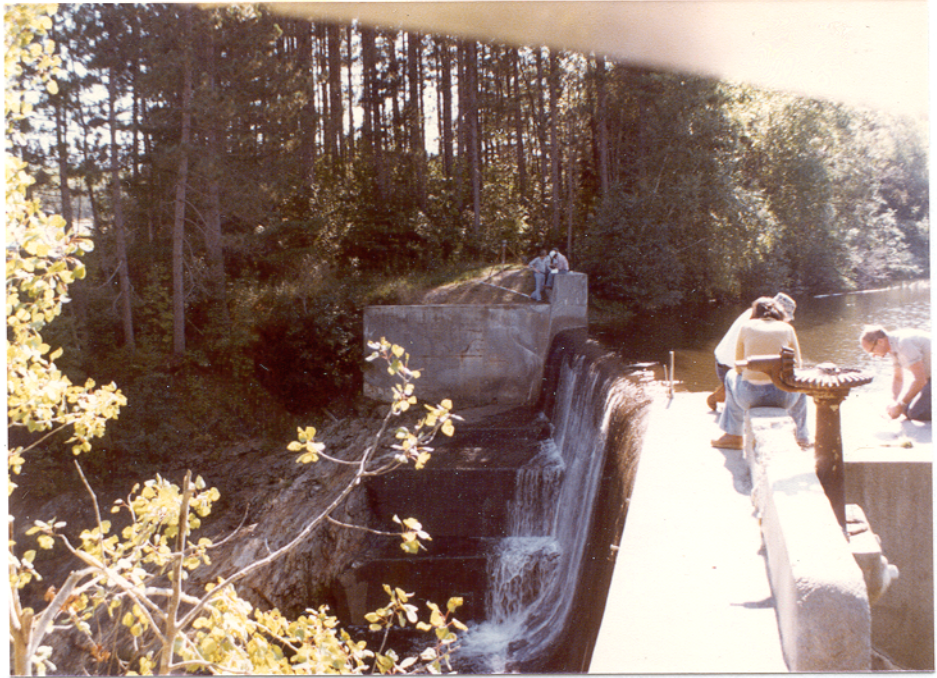
Figure 8 - Looking across crest from north abutment  
of the dam.

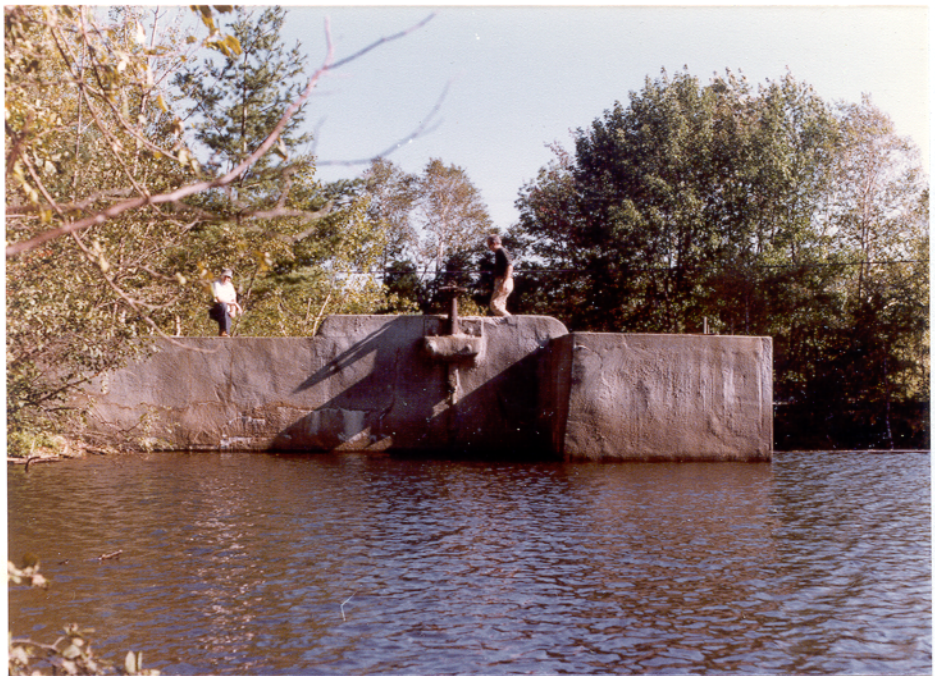
The plywood cover over the control tower will pose a dangerous condition to people walking on the cover if left uncorrected.

Figure 9 - Upstream face of the north abutment. View  
of control tower and gate mechanism.

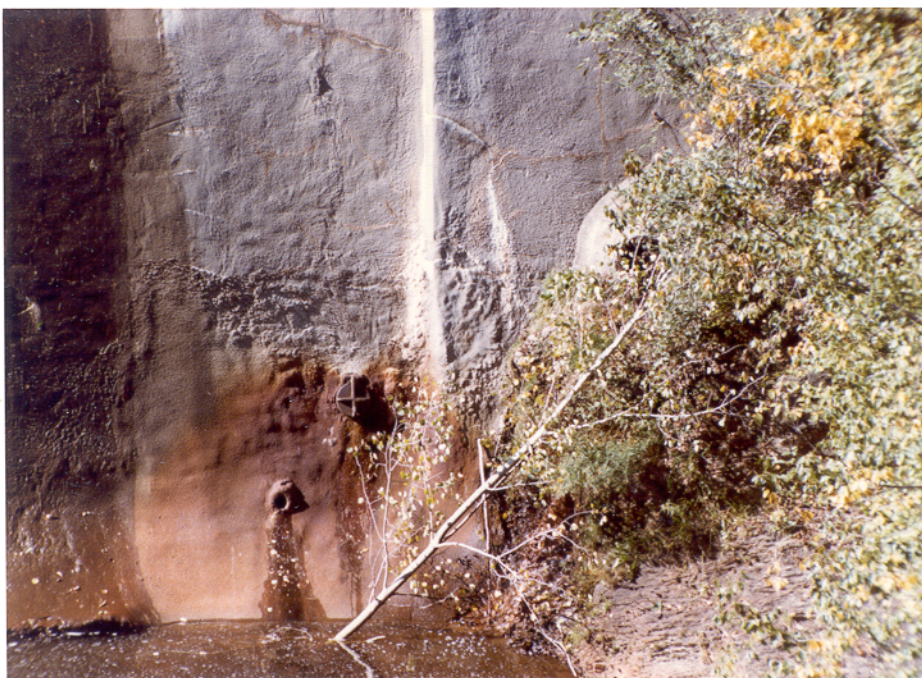
September 17, 1979  
 Figure 10 - View of two discharge pipes from the  
 intake structure.

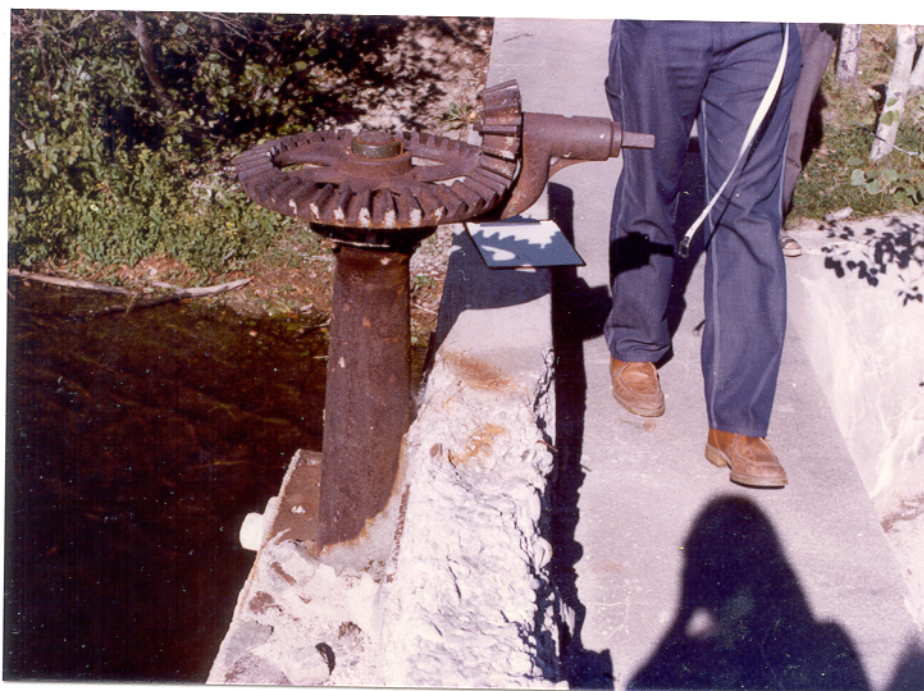
i. Normal Operating Procedures. No written operational procedures exist for Little River Upper Dam. The gate operating mechanism with 18-inch vcp outlet is rusted and is not in operable condition. Three inlet valve operators (that are reported to be operable), a valve chamber, and two outlet pipes are utilized to put discharge into the downstream channel to provide additional inflow into Reservoir Number 1 as required to meet demands.

September 17, 1979  
 Figure 11 - View of gate mechanism at the north  
 abutment.

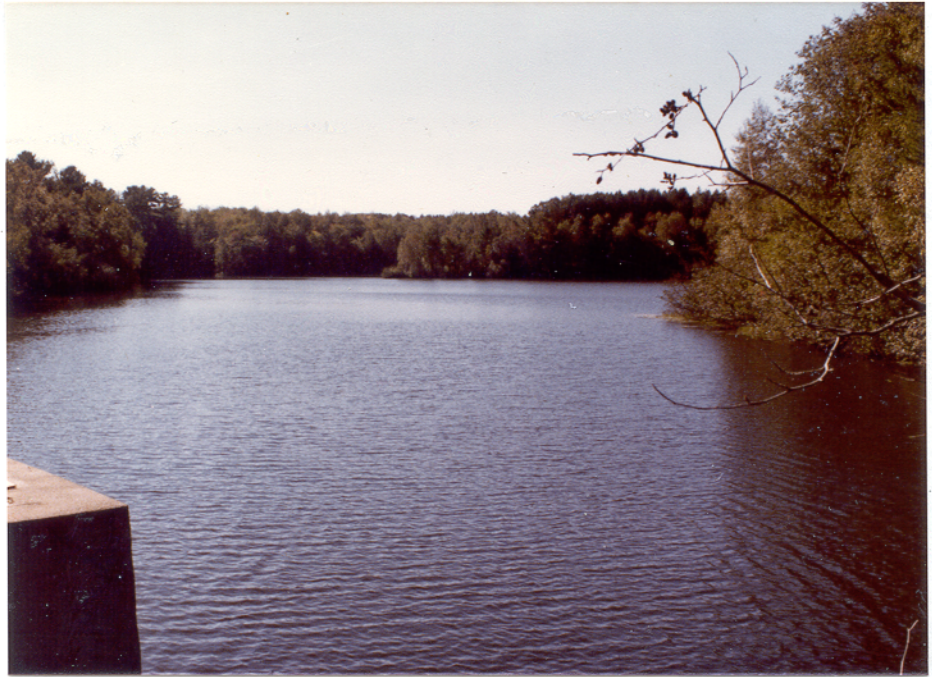
d. Reservoir Area. The watershed above the reservoir is rolling and partially wooded. (See Appendix C - Figure 12.) No structures were observed on the shore of the reservoir. No evidence of significant sedimentation in the reservoir was observed.

September 17, 1979  
 Figure 12 - Looking upstream at the reservoir from the  
 top of the north abutment.

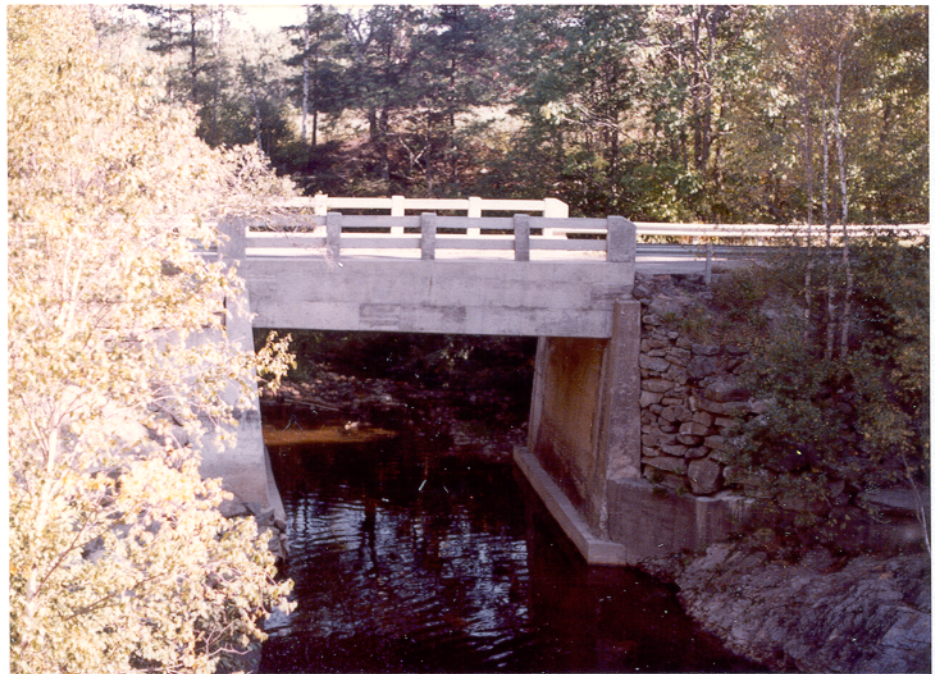
September 17, 1979  
 Figure 13 - Herrick Road Bridge 200' downstream of  
 the dam.

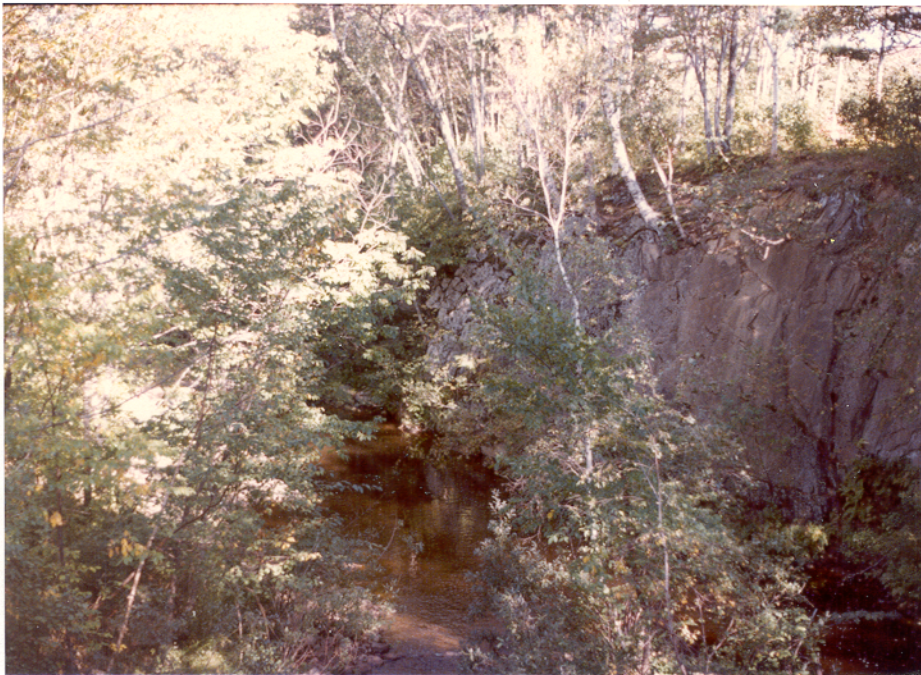
September 17, 1979  
Figure 14 - Looking at the downstream channel from  
the top of Herrick Road Bridge.
